Scientific Research Paper

# Preserving the Past: A Heritage Survey of St. Nikita Church

This paper presents the investigation conducted on St. Nikita church, which was selected as a representative Byzantine monument. The church was built in the 14<sup>th</sup> century and belongs to the group of domed cross-in-square plans. Investigation of the church involved: archival research, review of the available documentation, building surveys (visual and drone inspections), and recording. This integrated methodology provided insight into the historical context of the building, its current condition, and significance, which is crucial for developing future preservation strategies that consider both material and semantic aspects.

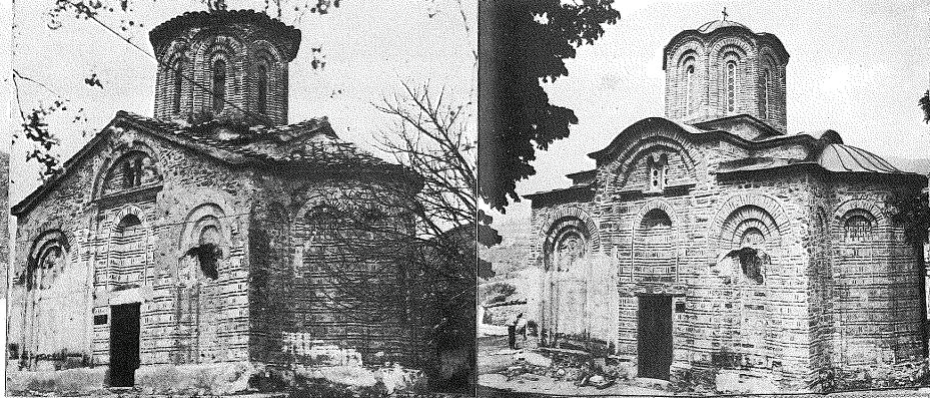
**Figure 2**

| 1978-80 | Extensive intervention on the roof parts: reconstruction of the roof and replacement of the roof tiles with a lead sheet, fig. 2 |

St. Nikita church, before (left) and after (right) the roof reconstruction

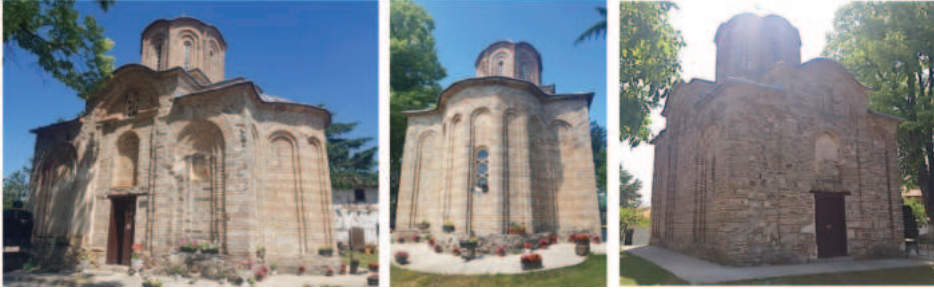
### Figure 3

The lowest zone of the church is in the form of a base upon which the church rises, made from roughly hew stones. This is a remnant from an older building. The facades of the church are playful with niches and arches, fig. 3. The northern, eastern, and southern facades are designed in a similar manner: alternating layers of dressed stone and brick and vertically placed bricks at the joints, i.e., “opus cloisonné” technique, with minor modifications. The eastern facade is emphasized by a five-sided apse and decorated with bricks in different patterns. Western facade differs from the others, it is made of a combination of roughly hew stone and bricks in irregular arrangement (Grujoska-Kuneska, 2024).

*St. Nikita church, south-east facade (left), east facade (middle), west facade (right)*

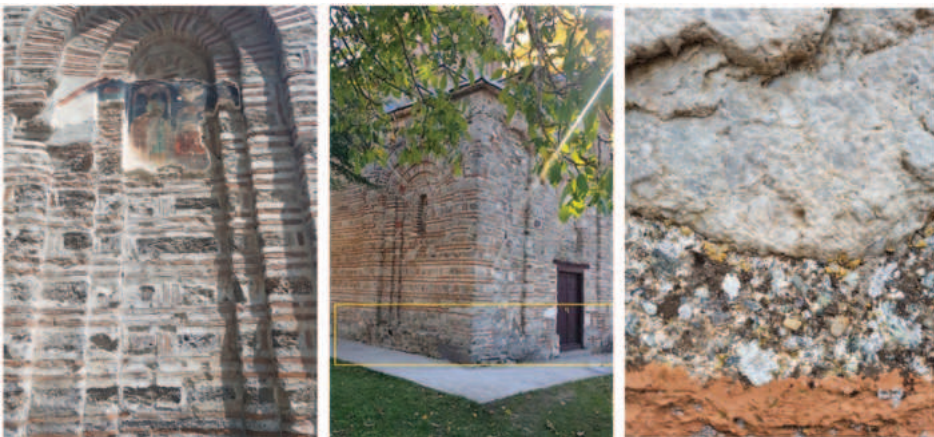
### Figure 4

Visual inspections on the facades enabled to map certain irregularities such as: porosity of the limestone and carbonization of the lime mortar; presence of capillary moisture in the lower zone of the northern and western walls; presence of lichens on all facades, fig. 4. However, general condition of the facades is considered as relatively good and preserved, without significant degradation or damage of the materials that could pose further threat to the monument (Grujoska-Kuneska, 2024).

*Surface irregularities on the facades of St. Nikita church: porosity on limestone (left), presence of moisture (middle), presence of lichens (right)*

Visual inspections enabled the mapping and documenting of some visible surface irregularities and pointed out some zones that need additional investigation. From this inspection, it was concluded that surface materials are in relatively good condition and preserved, but additional investigations are necessary to evaluate any potential hidden threats. This type of information helps to monitor changes over time and can be used as a valuable starting point for future preservation strategies.

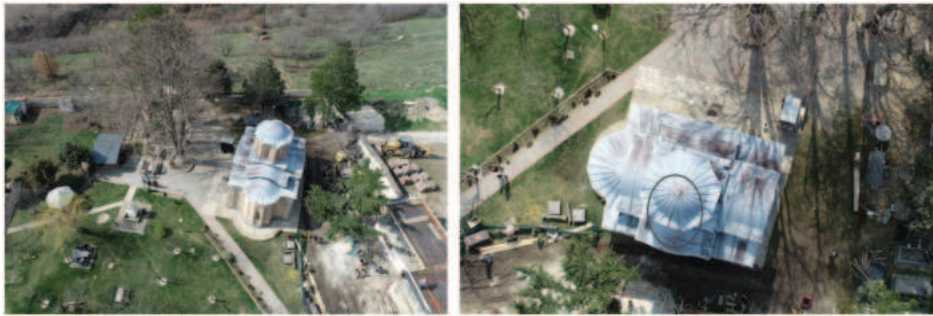
### **Figure 5**

The use of a drone provided information for some unreachable areas that were difficult to access during visual inspections, such as the rooftop of the church, without the risk of damaging the material. During these inspections, photographs with high resolution were attained (Fig. 5), presenting the church within its surroundings from an aerial perspective. This gave the opportunity to look into the roof's covering, and it was observed that the sheet (cover material) is in good condition, except for a small part of the dome, where some cracks were noticed, probably due to unprofessional fixing of the joints (Grujoska-Kuneska, 2024).

*Drone photographs showing aerial perspective of the church and minor damage on the dome covering (right)*

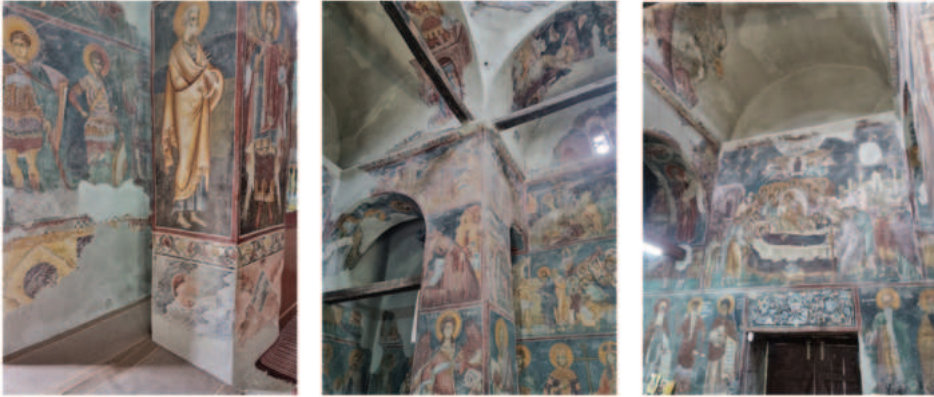
**Figure 6**

Interior surfaces of the church are completely plastered and covered with frescoes, preserved on a large scale; therefore, the condition of the structure materials cannot be investigated. These frescoes belong to three different periods: 14<sup>th</sup> century, 15<sup>th</sup> and 19<sup>th</sup> century, (Markovic, 2015). In some zones - lower zones of the walls and columns and partly in the vaults, the frescoes are missing and only plastered surfaces are visible, fig. 6.

*St. Nikita church - interior*

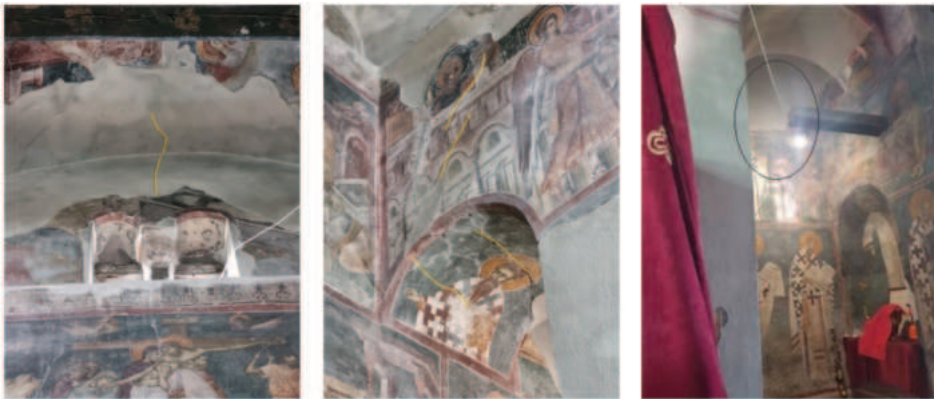
**Figure 7**

During these visual inspections, fine cracks were observed in some upper zones of the walls and vaults. The most pronounced is the old crack on the western wall, located above the door, which needs additional investigation. Also, it was observed that one of the wooden ties (the one that connects the altar area and the north-east column) is discontinued, which can be considered as more serious damage since this element contributes to the overall seismic performance of the building, Fig. 7 (Grujoska-Kuneska, 2024).

*Damage in the upper zones of the church, micro cracks (left and middle), discontinuity of a wooden tie (right)*
