Scientific Research Paper

# Renovation of an Old Istrian Building

The seminar paper focuses on transforming a historical stone structure in Istria into a boutique restaurant, adhering to the principles of cultural and architectural preservation. The research encompasses the history and traditional construction methods of the Istrian peninsula, analyzing types of vernacular architecture and the use of local materials like stone. It emphasizes the importance of preserving historical elements while incorporating modern design to meet contemporary standards. The research outlines a detailed process for renovation, including theoretical research, and site analysis. It highlights the historical and cultural significance of Strunjan, where the project is located, linking the building's renovation to the broader development of tourism in the area. The project not only restores a neglected structure but also redefines it as a vibrant cultural and culinary destination, enhancing the region's identity while respecting its heritage. This work serves as a model for sustainable preservation and adaptive reuse of historical buildings.

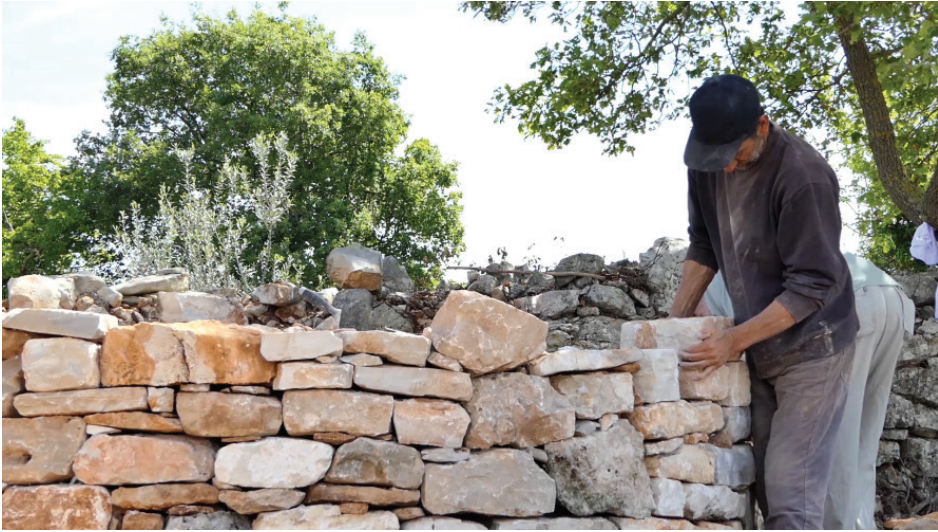
**Figure 3**

*Dry stone construction. (Macuka, 2019)*

In dry stone construction, in the strictest sense of the word, only natural material—stone—is used. Since it was always gathered from the nearest surroundings, the diversity of the stone composition means that dry stone walls differ almost from village to village. Part of the effort within this task is focused on determining the typology of dry stone construction based on the type of stone (predominantly sandstone) and local building peculiarities (Orbanić et al., 2015, p. 9).

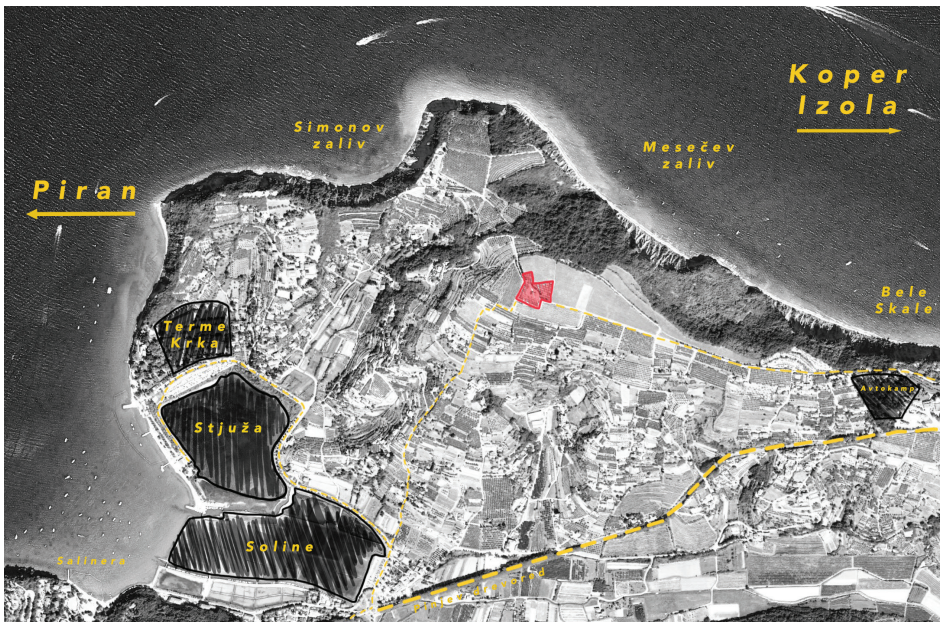
**Figure 4**

*Analysis of the studied area*

The old Istrian house is located in the municipality of Izola. The building offers a beautiful view of the Strunjan Bay, Piran Punta and Cape Ronek to the west, and Izola and Koper to the north. The plot extends in the area of Dobrava, which borders the Strunjan Landscape Park. The property is accessible by local road from the Belveder-Strunjan and Strunjan-Belveder directions. Behind the plot is the Strunjan footpath, which is part of the Strunjan landscape park. It is a connection between the municipalities of Piran and Izola.

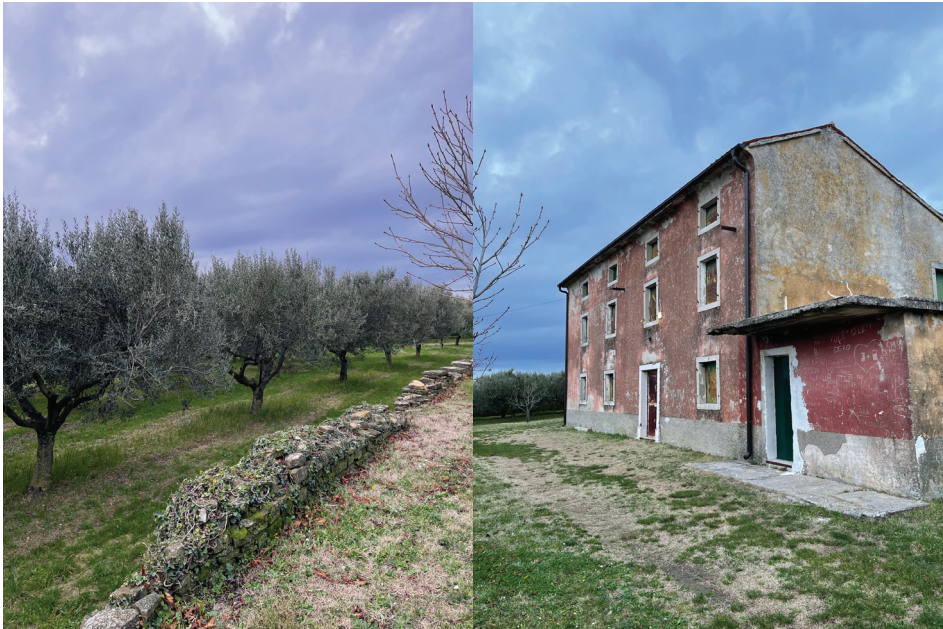
**Figure 5**

*Existing condition of the building's exterior*

The three-story building is currently used for storing tools. The owners are engaged in agriculture and are well-known producers of olive oil under the brand name “Kmetija Ronko Izola”. They also once lived there. Due to wear and tear, the house is in quite poor condition. It needs a complete renovation. It has utility connections, but they are not connected to the building.

The only joinery on the building is represented by doors, and the window portals are covered with metal bars that prevent break-ins and the entry of animals. Despite constant repairs, the roof is dilapidated and needs to be replaced. The walls of the house are built of double drywall and, given its age, have no thermal insulation. The floors, which are covered with concrete on the ground floor, have begun to crack over the years, and with the addition of extensions, the owners did not pay attention to the same pressure level. The floors are connected by steep stairs that lead to a connecting corridor between the left and right wings of the building. From there, impassable, crumbling stairs lead to the attic. Due to the poor condition of the wood, the floors on the first floor are also impassable in some places. provided access to the attic. Due to wood deterioration, parts of the upper floors are impass-

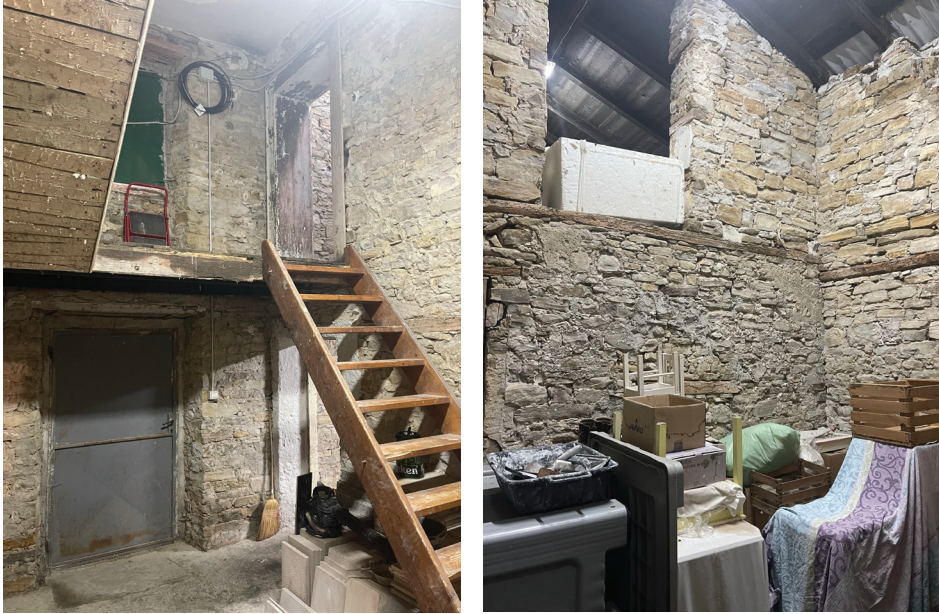
### Figure 6

*Existing condition of the interior*

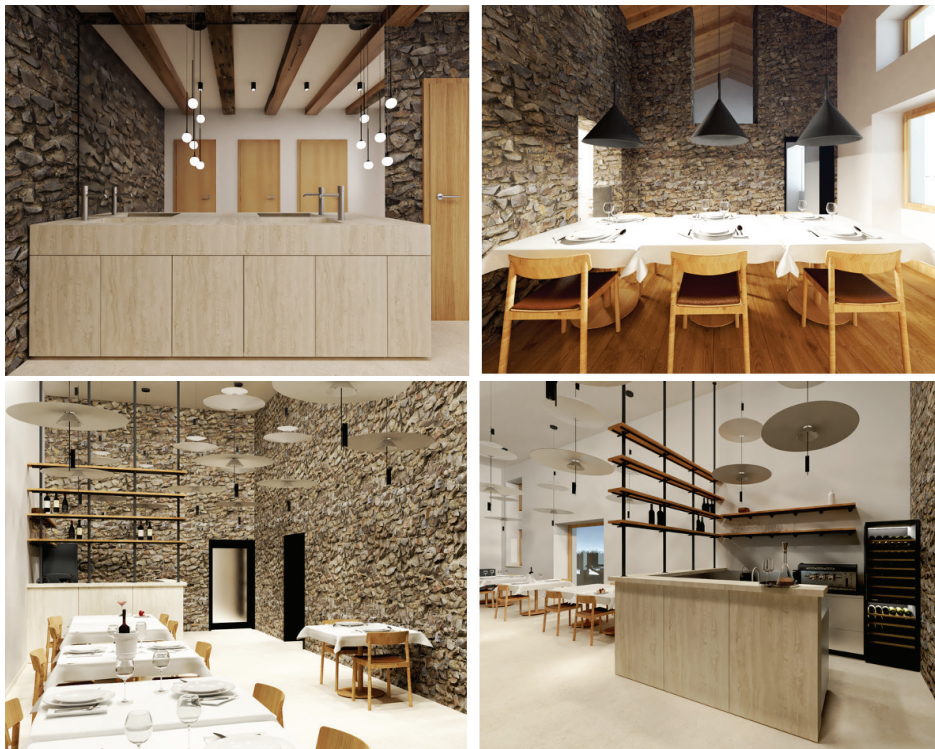
**Figure 8**

*Visualizations of the conceptual renovation design (Lukić, 2025)*

After consulting with the clients, they decided to renovate the dilapidated building into a boutique restaurant with local produce and food that is traditional to the local area. With the renovation, we have strived to preserve as much of the existing architectural features of traditional Istrian construction as possible and to renovate poorly preserved exterior elements. The renovation included replacing the roof with local roofing, “korci”, and a new canopy over the terrace, which will serve as the outdoor part of the restaurant. We have removed the plaster from the building to expose the raw stone, which we will restore appropriately. This will bring the Istrian house back to life and give it its original appearance. We will design a parking lot for guests and employees on the plot, and renovate the courtyard to match the new appearance of the building.
